**Flood Control Project Maintenance  
Levee Inspections**

**Spring 2013 Levee Inspection Results**

**Reclamation District No. 0556 Upper Andrus**

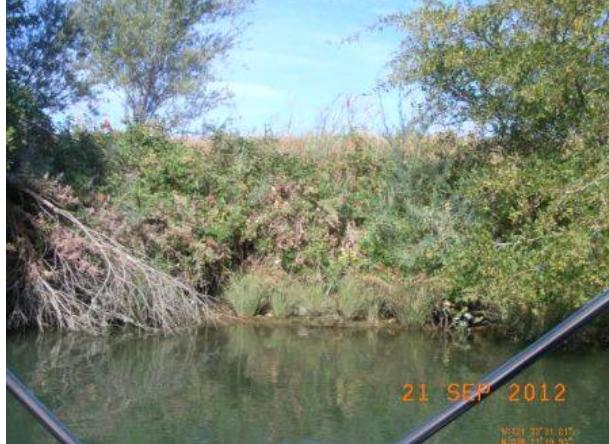
USACE 2012 Photo #1

Levee Mile Report Line	71
Start Levee Mile	5.11
End Levee Mile	5.26
Location	Water Side
Category	Supplemental
Item	USACE Erosion Survey

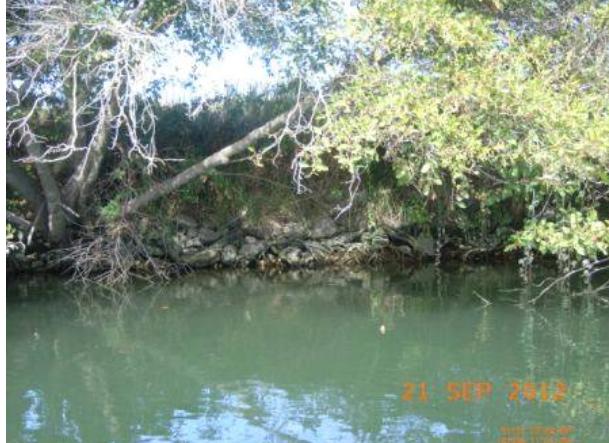
USACE 2012 Photo #2

Levee Mile Report Line	71
Start Levee Mile	5.11
End Levee Mile	5.26
Location	Water Side
Category	Supplemental
Item	USACE Erosion Survey

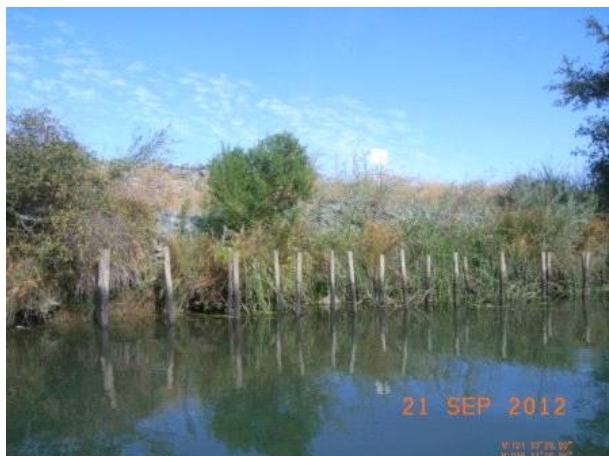
USACE 2012 Photo #3

Levee Mile Report Line	71
Start Levee Mile	5.11
End Levee Mile	5.26
Location	Water Side
Category	Supplemental
Item	USACE Erosion Survey

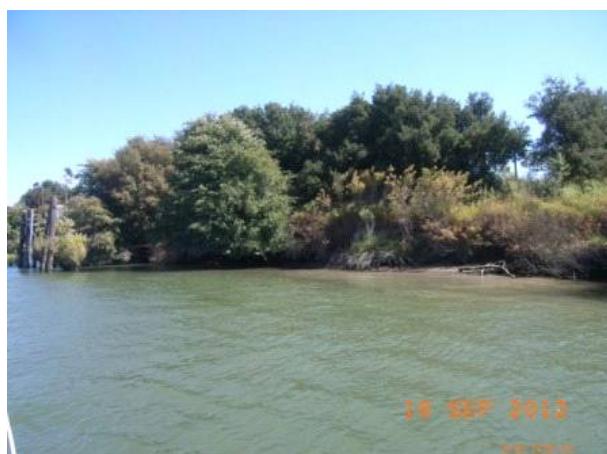
Levee Mile Report Line	11
Start Levee Mile	0.31
End Levee Mile	0.60
Location	Water Side
Category	Supplemental
Item	USACE Erosion Survey
USACE 2012 Photo #1	
phillips_s_20130228_187.jpg

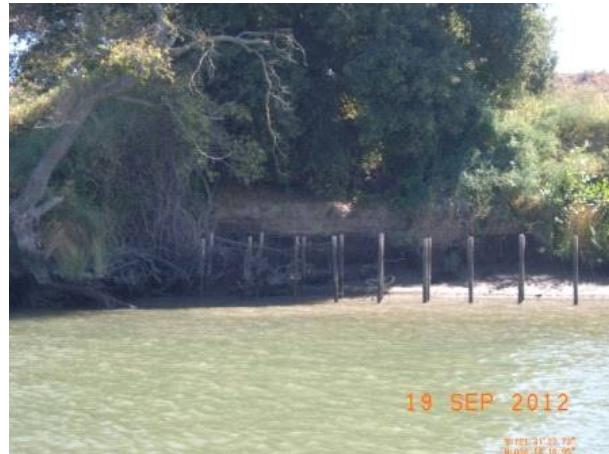
USACE 2012 Photo #3

Levee Mile Report Line	11
Start Levee Mile	0.31
End Levee Mile	0.60
Location	Water Side
Category	Supplemental
Item	USACE Erosion Survey

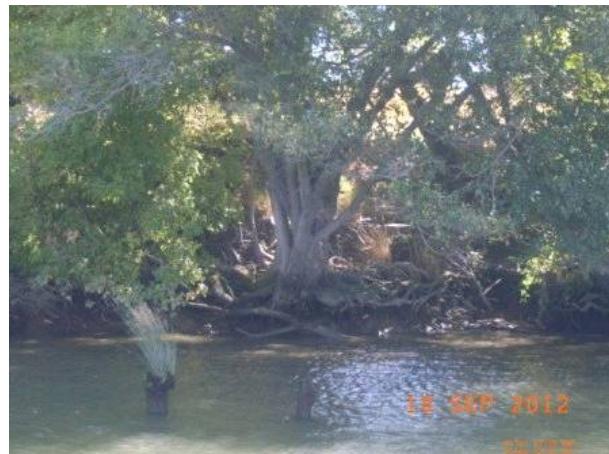
USACE 2012 Photo #4

Levee Mile Report Line	11
Start Levee Mile	0.31
End Levee Mile	0.60
Location	Water Side
Category	Supplemental
Item	USACE Erosion Survey

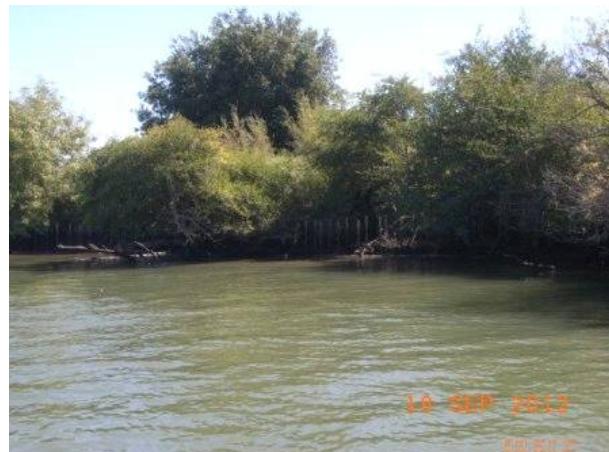
Levee Mile Report Line	19
Start Levee Mile	1.08
End Levee Mile	1.16
Location	Water Side
Category	Supplemental
Item	USACE Erosion Survey
USACE 2012 Photo #1	
phillips_s_20130228_192.jpg

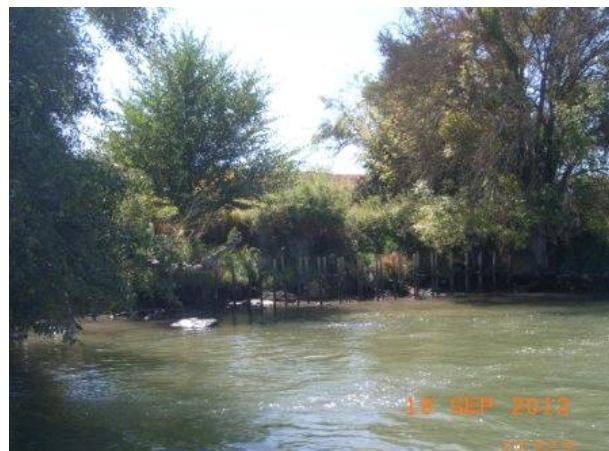
Levee Mile Report Line	19
Start Levee Mile	1.08
End Levee Mile	1.16
Location	Water Side
Category	Supplemental
Item	USACE Erosion Survey
USACE 2012 Photo #2	
phillips_s_20130228_193.jpg

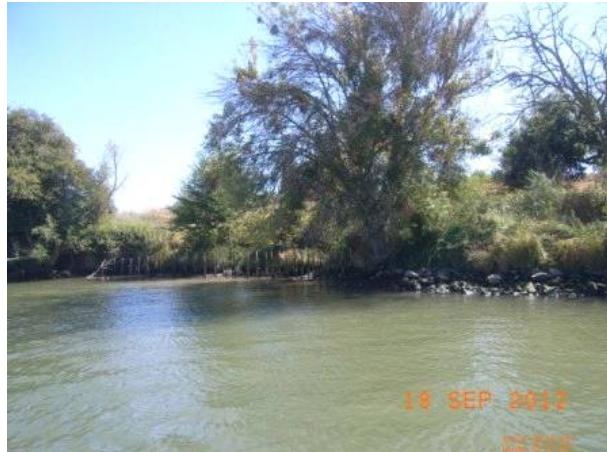
Levee Mile Report Line	19
Start Levee Mile	1.08
End Levee Mile	1.16
Location	Water Side
Category	Supplemental
Item	USACE Erosion Survey
USACE 2012 Photo #3	
phillips_s_20130228_194.jpg

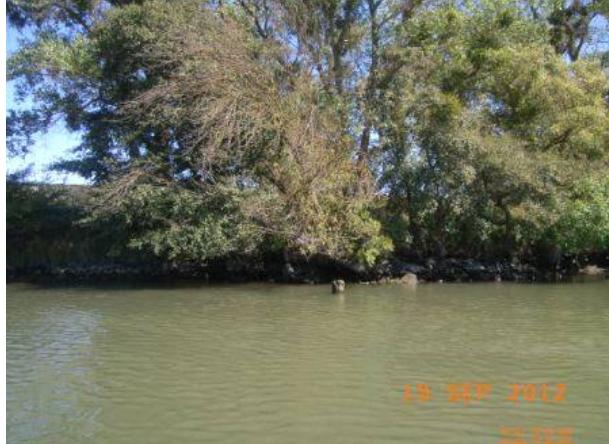
USACE 2012 Photo #1

Levee Mile Report Line	40
Start Levee Mile	2.93
End Levee Mile	3.05
Location	Water Side
Category	Supplemental
Item	USACE Erosion Survey

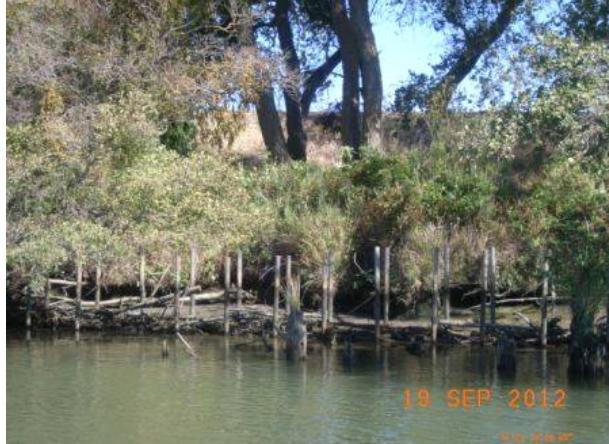
USACE 2012 Photo #2

Levee Mile Report Line	40
Start Levee Mile	2.93
End Levee Mile	3.05
Location	Water Side
Category	Supplemental
Item	USACE Erosion Survey

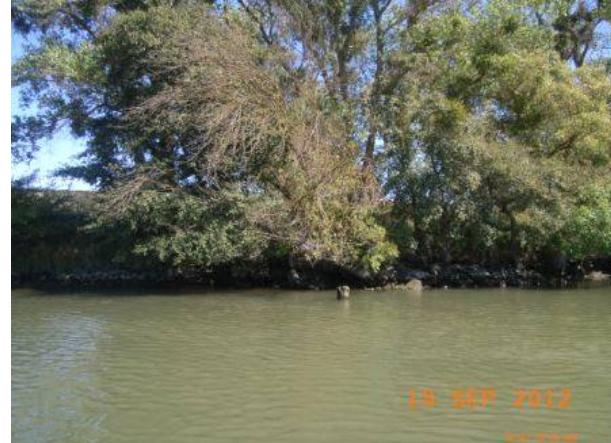
Levee Mile Report Line	40
Start Levee Mile	2.93
End Levee Mile	3.05
Location	Water Side
Category	Supplemental
Item	USACE Erosion Survey

USACE 2012 Photo #3
phillips_s_20130228_202.jpg

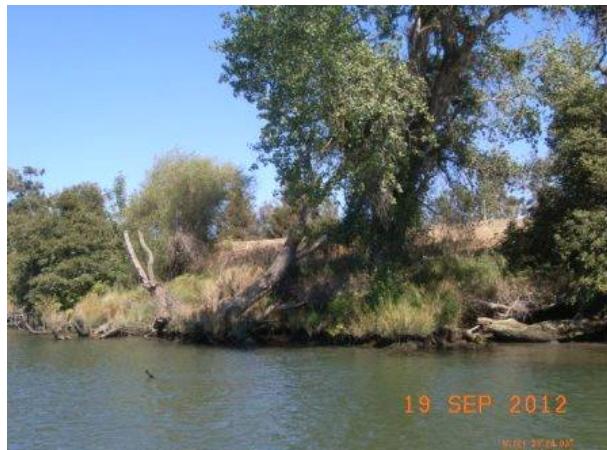
USACE 2012 Photo #2

Levee Mile Report Line	46
Start Levee Mile	3.58
End Levee Mile	3.63
Location	Water Side
Category	Supplemental
Item	USACE Erosion Survey

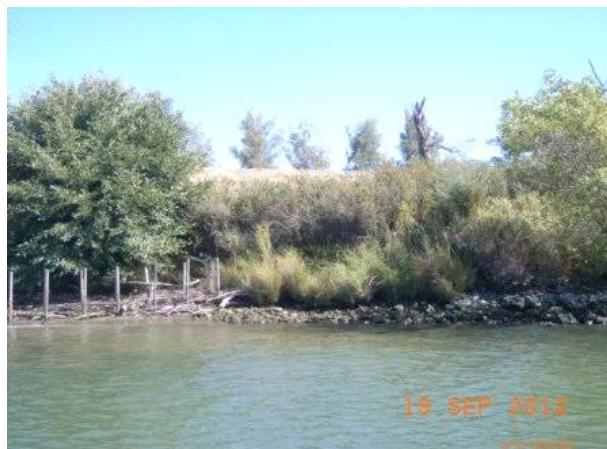
USACE 2012 Photo #3

Levee Mile Report Line	46
Start Levee Mile	3.58
End Levee Mile	3.63
Location	Water Side
Category	Supplemental
Item	USACE Erosion Survey

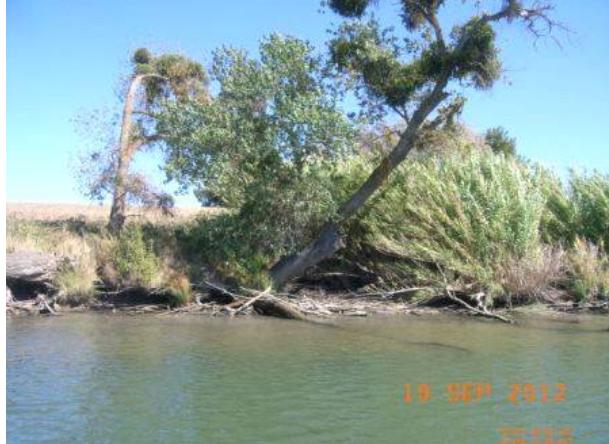
USACE 2012 Photo #1

Levee Mile Report Line	50
Start Levee Mile	3.95
End Levee Mile	4.12
Location	Water Side
Category	Supplemental
Item	USACE Erosion Survey

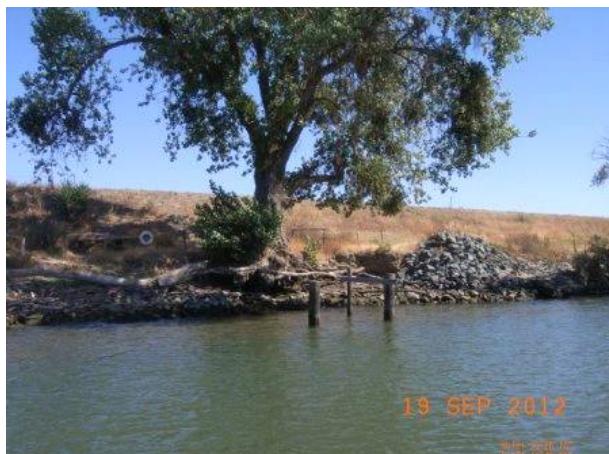
USACE 2012 Photo #2

Levee Mile Report Line	50
Start Levee Mile	3.95
End Levee Mile	4.12
Location	Water Side
Category	Supplemental
Item	USACE Erosion Survey

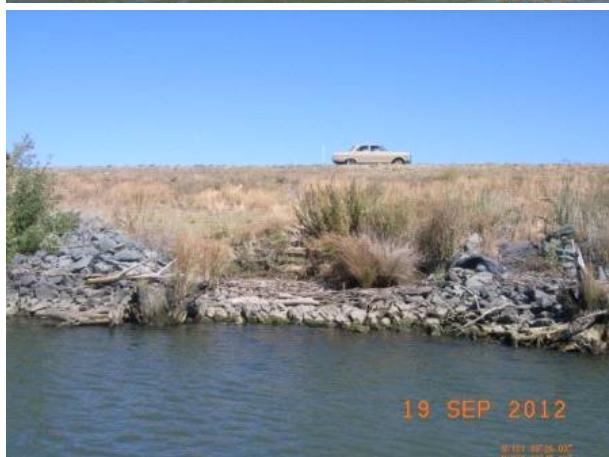
USACE 2012 Photo #3

Levee Mile Report Line	50
Start Levee Mile	3.95
End Levee Mile	4.12
Location	Water Side
Category	Supplemental
Item	USACE Erosion Survey

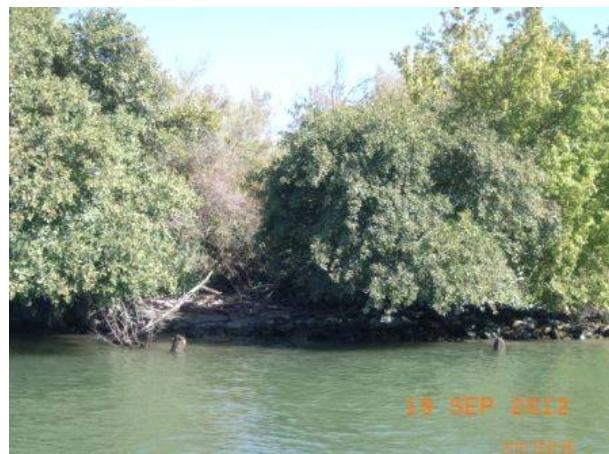
Levee Mile Report Line	67
Start Levee Mile	4.85
End Levee Mile	4.88
Location	Water Side
Category	Supplemental
Item	USACE Erosion Survey
USACE 2012 Photo #1	
phillips_s_20130228_213.jpg

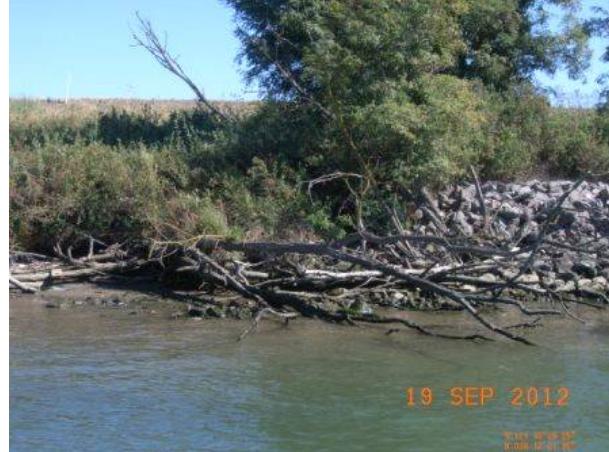
Levee Mile Report Line	67
Start Levee Mile	4.85
End Levee Mile	4.88
Location	Water Side
Category	Supplemental
Item	USACE Erosion Survey
USACE 2012 Photo #2	
phillips_s_20130228_214.jpg
